Heritage renovation of part of the roof of the Church Saint Vincent de Paul - Clichy (92) - France

PUBLIC BUILDING : Heritage restoration, refurbishment

Client	City of CLICHY-LA GARENNE
Location	CLICHY (92110), France
PROJECT MISSION	Heritage renovation of part of the roof of the Saint Vincent de Paul church
CONSULTANTS	AR ARCHITECTES
Date	Beginning of the diagnosis in 2026

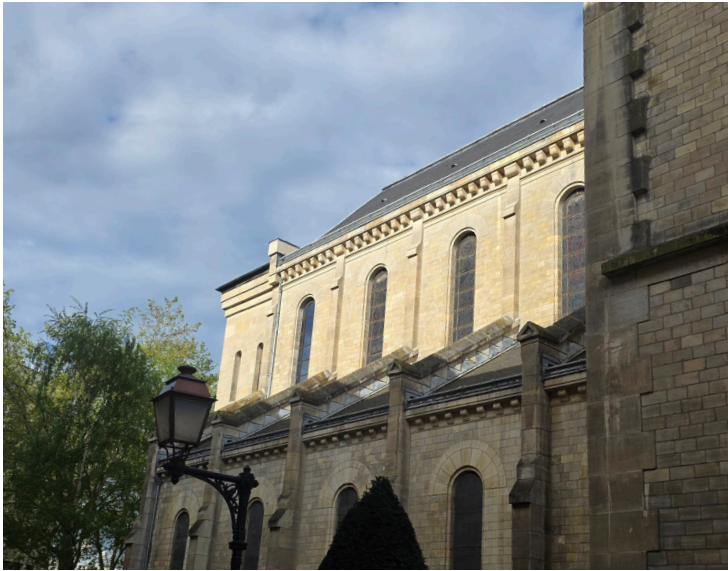
The lean-to roof covering the side aisle of the Saint Vincent de Paul church, located to the southeast of the building.

- The restoration of the lean-to roof covering the side aisle of the Saint Vincent de Paul church, located to the southeast of the building, to match the existing structure. The exterior work includes replacing the slate roofing, including the zinc flashing on the parapet walls and the zinc gutter.

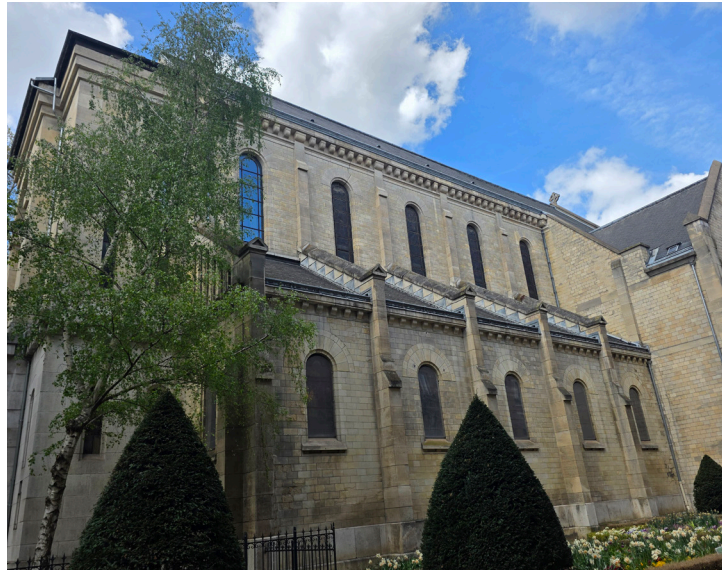
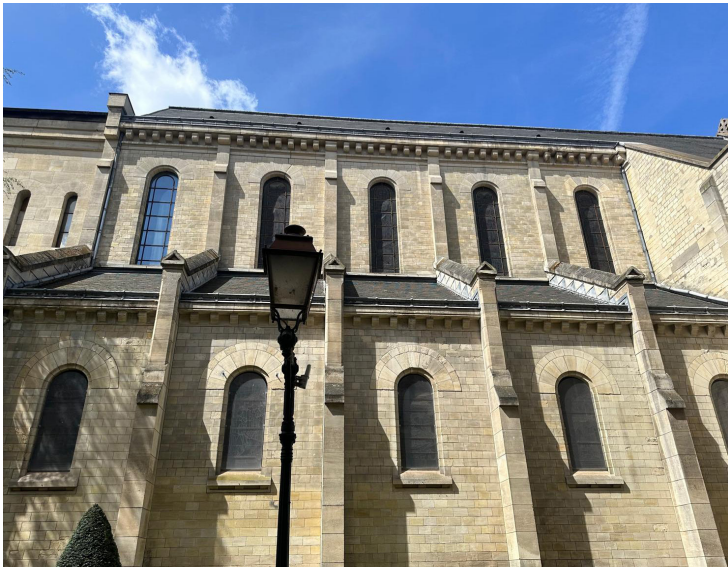
The replacing the slate roofing.

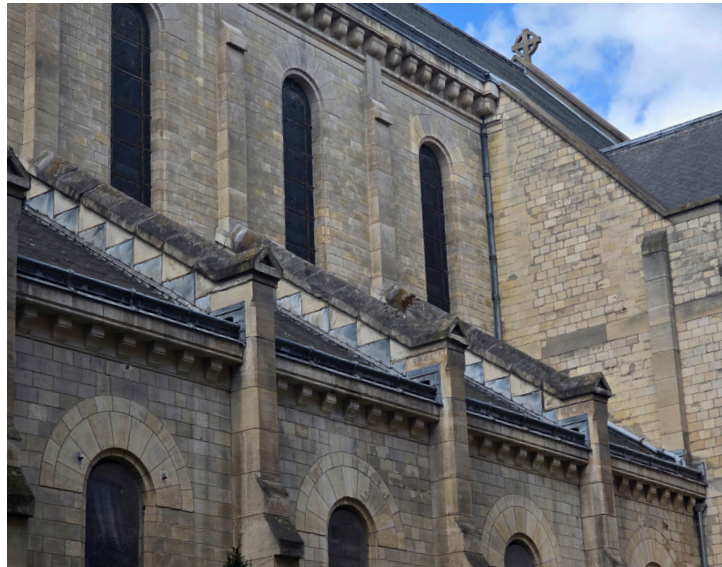
The zinc flashing on the parapet walls and the zinc gutter.
